*BRUSH WELLMAN, INC.*

Topaz Mine

1994 ANNUAL REPORT  
of Mining Operations

DATE: January 20, 1995  
TO: Greg Hawkins  
FROM: Tom Millwee and Clyde Yates  
SUBJECT: Reclamation work

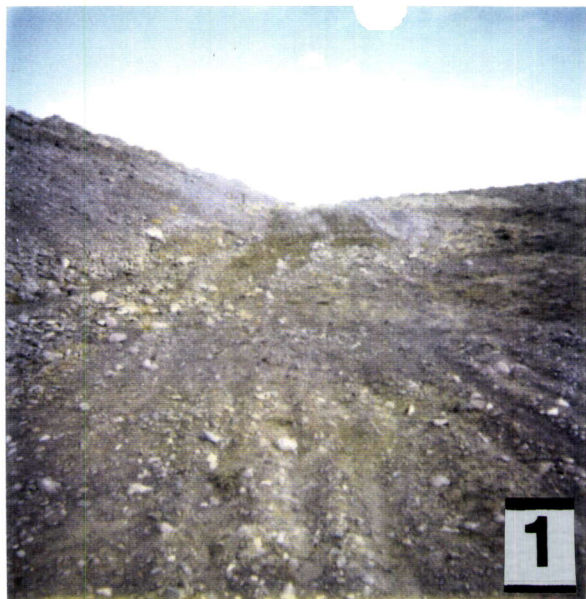
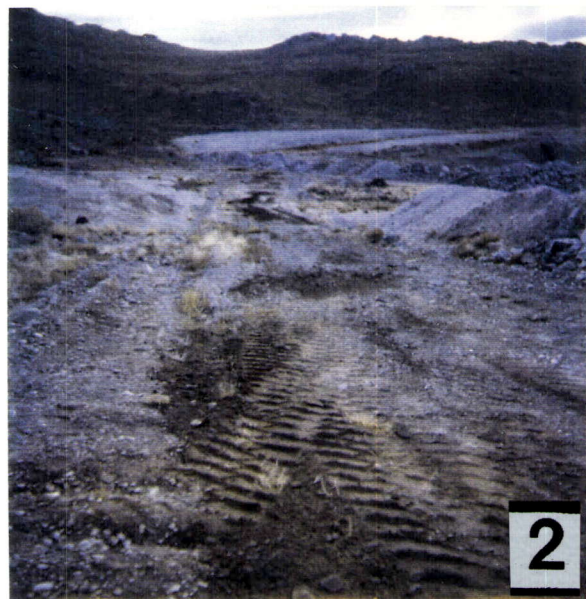
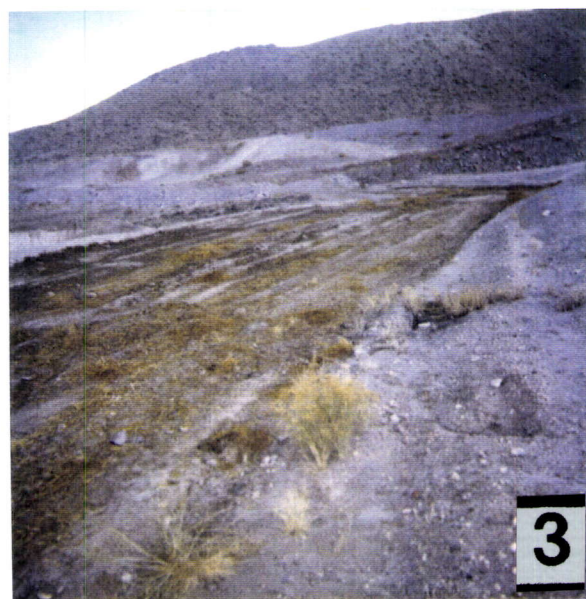
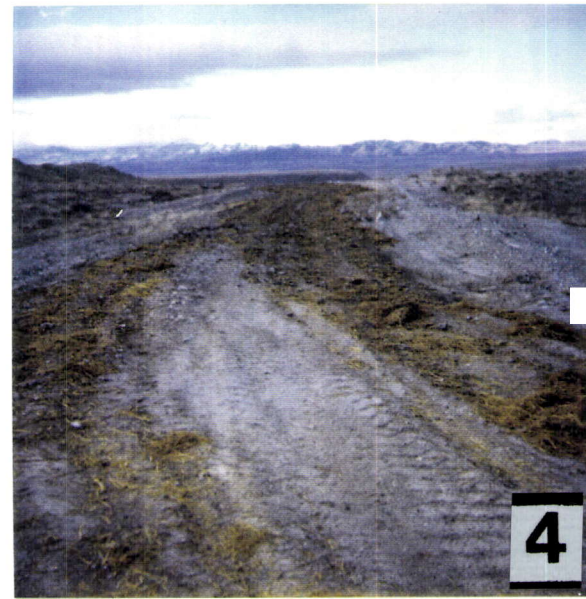
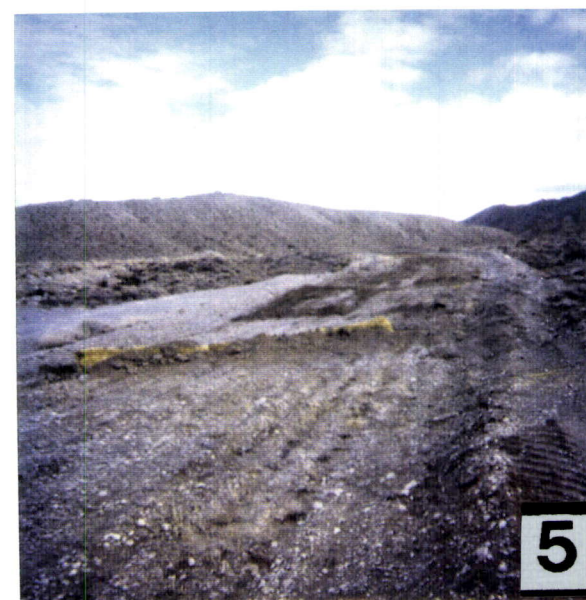
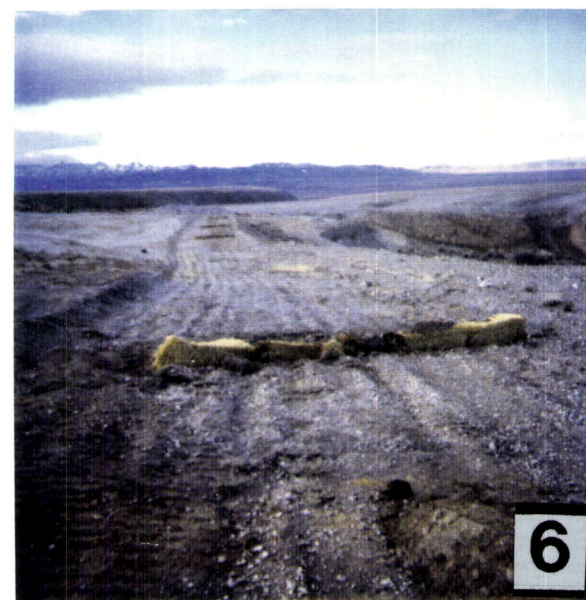
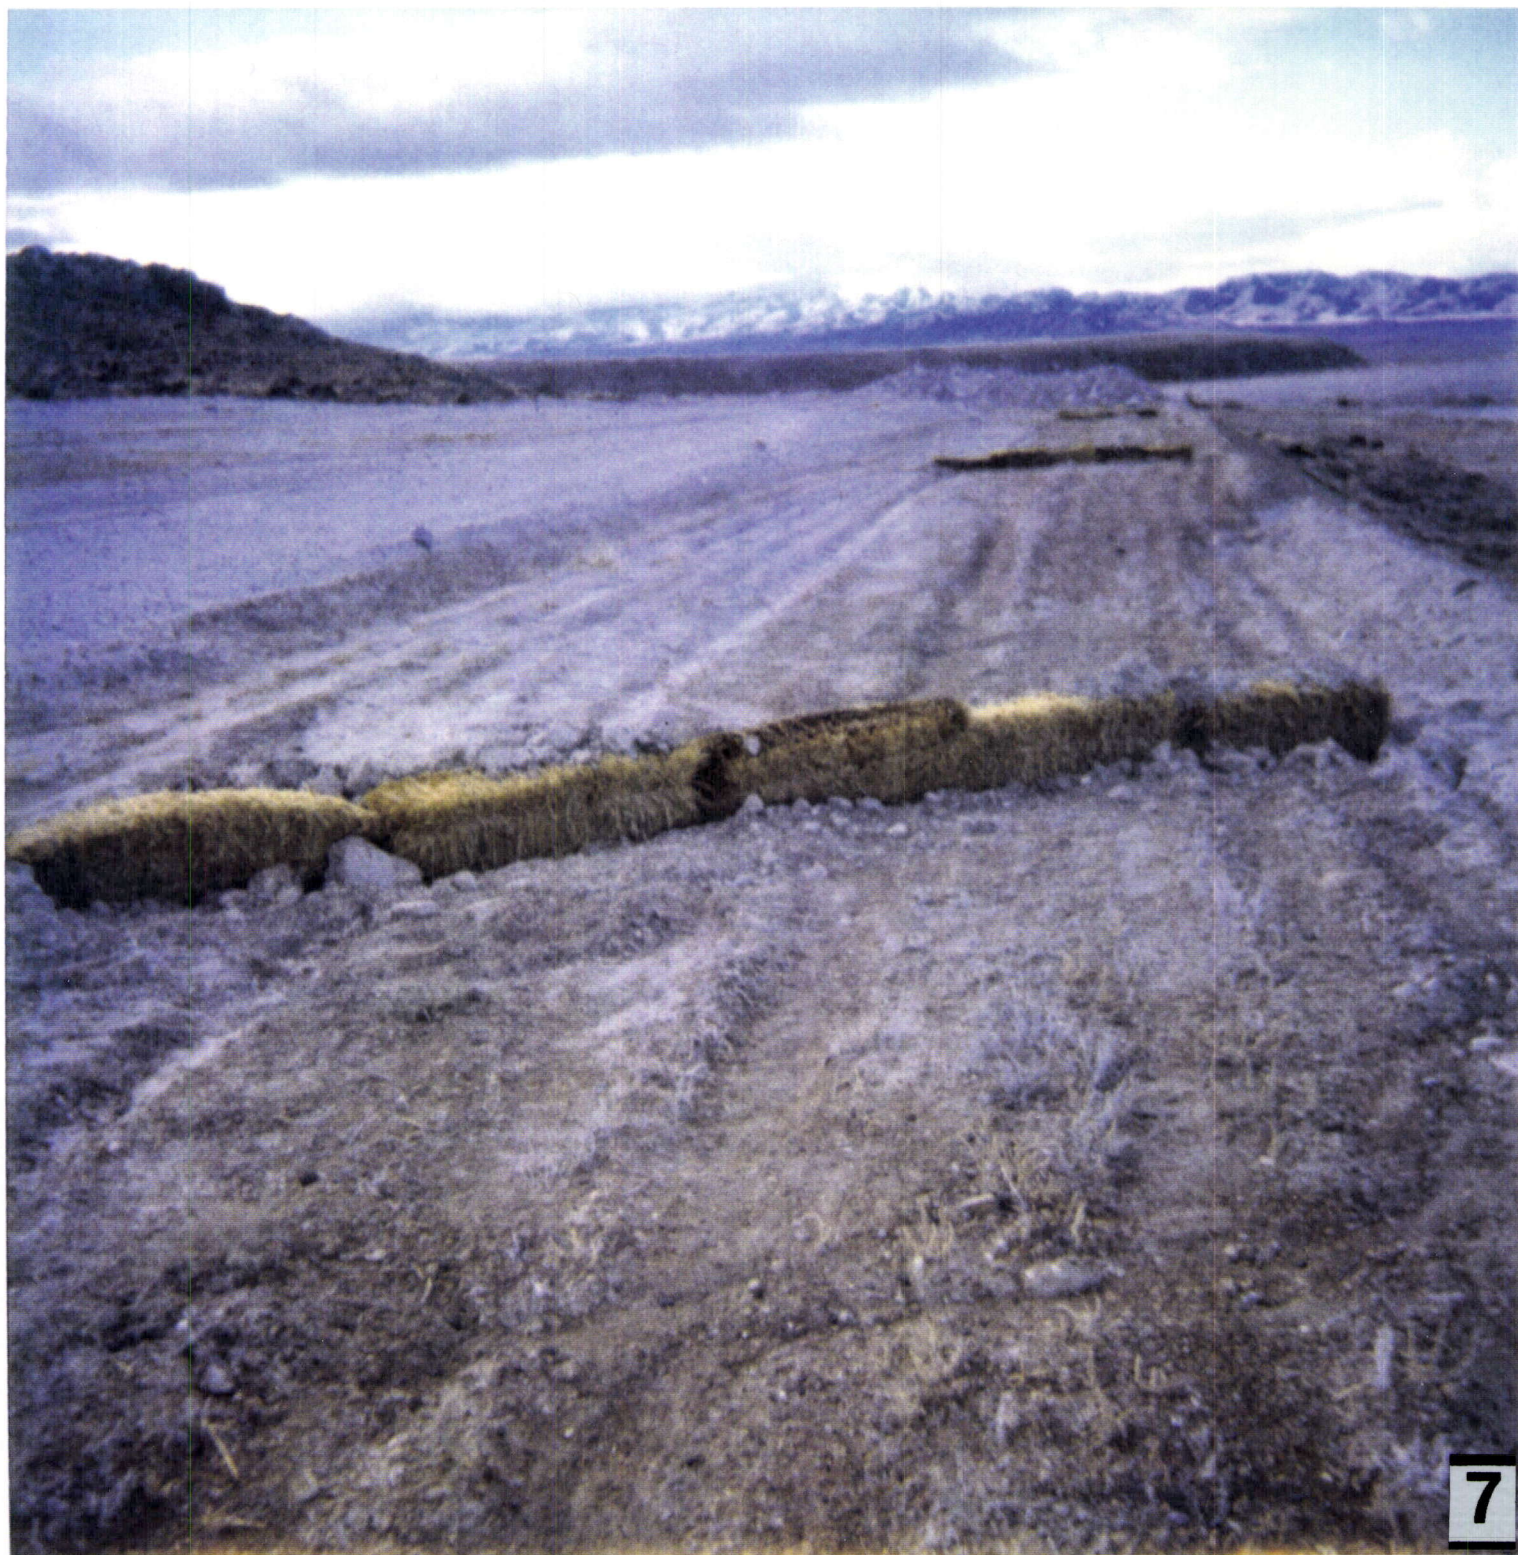
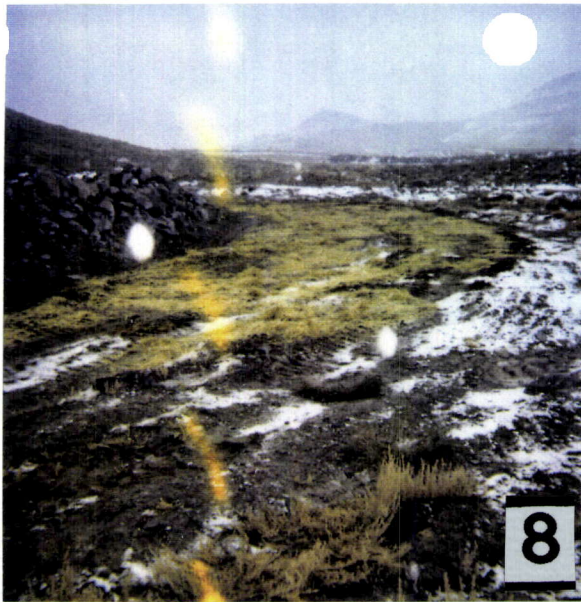
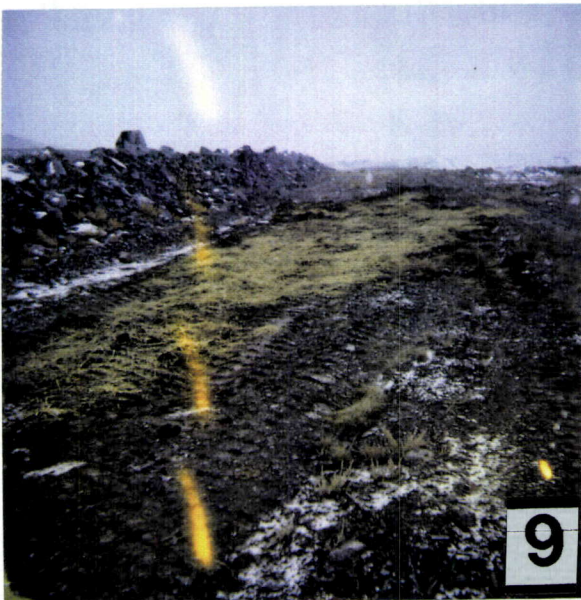
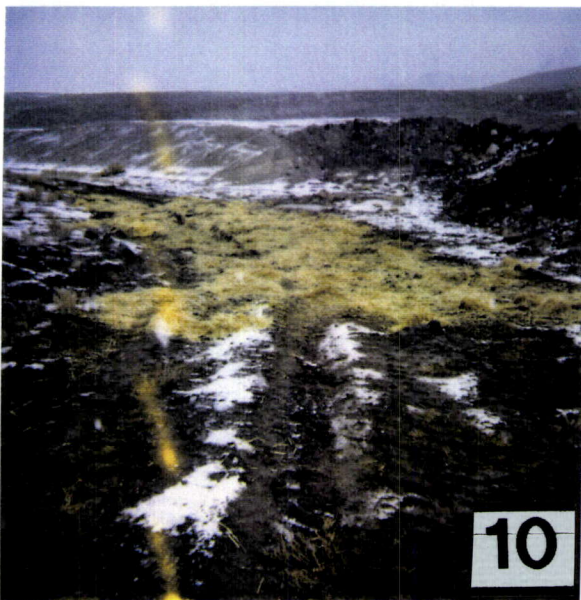
- Photo 1**      Picture of the SE corner of the Taurus dump, looking northwesterly. This area is estimated at 0.10 acres. It was treated with topsoil, gypsum and seed mix.

- Photo 2**      Picture of the reclaimed road north of the Sigma Emma pit, looking southeasterly. This area is estimated at 0.15 acres. It was treated with topsoil, gypsum and seed mix.

- Photo 3**      Picture of the reclaimed road east of the Sigma Emma pit, looking northerly. This area is estimated at 0.20 acres. It was treated with topsoil, gypsum, straw and seed mix.

- Photo 4**      Picture of the reclaimed road northeast of the Sigma Emma pit, looking southeasterly. This area is the same as in Photo 3, except viewed from the other end.

- Photo 5**      Picture of the northernmost waterbar and the reclaimed road east of the Sigma Emma pit, looking northeasterly. This area is estimated at 0.35 acres. It was treated with topsoil, gypsum, straw and seed mix.

- Photo 6**      Picture of the series of waterbars on the reclaimed road east of the Sigma Emma pit, looking southwesterly. Acreage is not estimated for this work. The waterbars will divert drainage away from the road and into the pit confines.

- Photo 7**      Picture of waterbars and road berm on reclaimed road east of the Sigma Emma pit, looking southwesterly. This is the same area as Photo 6, except viewed from farther down line.

- Photo 8**      Picture of the reclaimed road south of the Taurus pit, looking easterly. This area is estimated at 0.10 acres. It was treated with topsoil, gypsum, straw and seed mix.

- Photo 9**      Picture of the reclaimed road east of the Taurus pit, looking southerly. This area is estimated at 0.05 acres. It was treated with topsoil, gypsum, straw and seed mix.

- Photo 10**     Picture of the reclaimed road east of the Taurus pit, looking northerly. This area is estimated at 0.05 acres. It was treated with topsoil, gypsum, straw and seed mix.

Five water bars were constructed out of straw by digging down six inches, then placing straw in the trench and back-filling with dirt as shown on accompanying photos, running along the east reclaimed road near Sigma Emma pit.

Reclamation work also has been completed on the Taurus and Sigma Emma areas as shown on plat and in the photos.
